BUILDING 2045

CONDITION SURVEY DATA SHEET

CONDITION SURVEY

SHOP

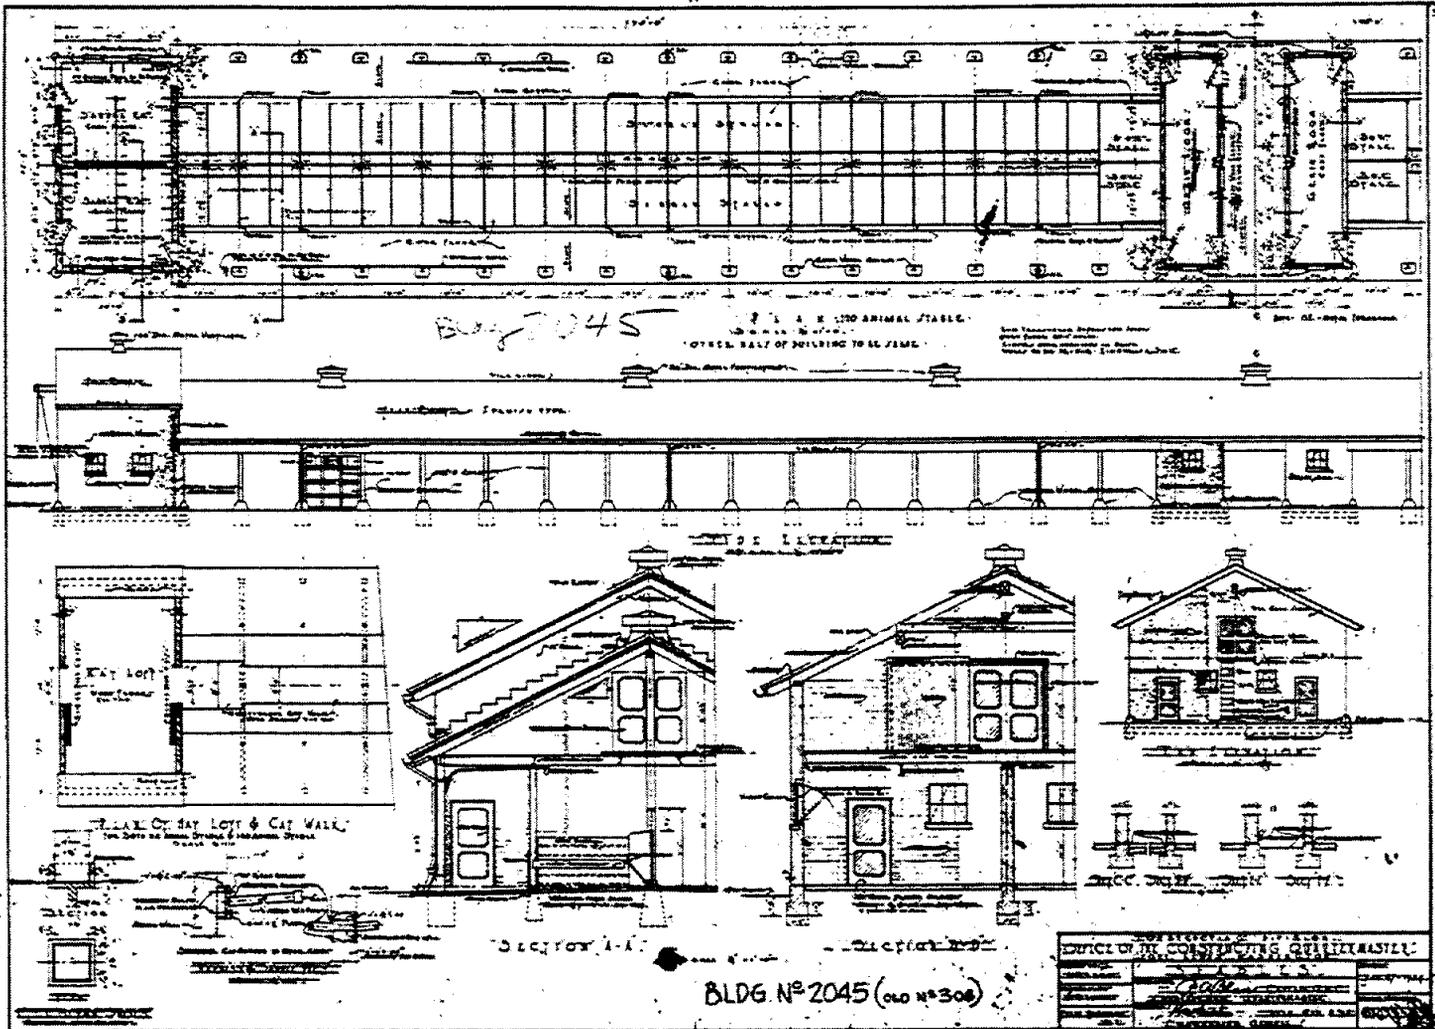
Building 2045 (formerly 308) is a long masonry shop building, built in 1934 as a stable. It has a hay loft at both ends over the saddle rooms. It originally had a continuous cat walk the length of the attic space and a continuous manger along the length of the floor slab.

The building has a tile roof, sheet metal soffits and steel sash windows with masonry sills. Several diagonally paneled man doors remain. Many openings have been infilled with drop siding.
